MEMORANDUM

To: Development Review Board
From: Ken Lerner
Date: June 4, 2013
RE: 13-1039CA/CU; 287-289 South Winooski Avenue

Request: Demolish historic garage, install fence and new parking area.

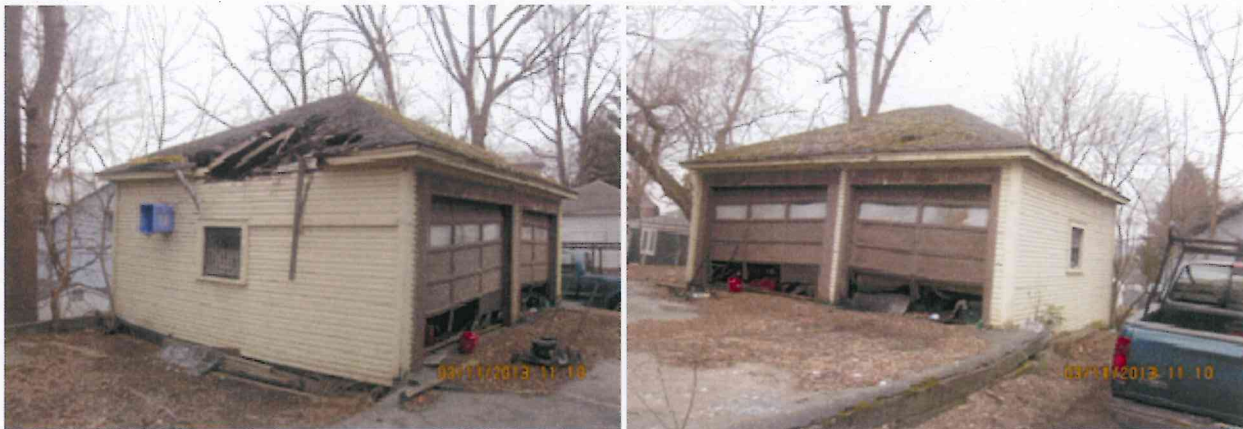
The subject building is a 23' x 18' timber framed hipped roof two-car garage with clapboard siding. It was listed on the State Historic Sites and Structures Survey in 1977 and on the Burlington Register of Historic Resources, prepared under a Certified Local Government Grant, in 2000-2001. The principle structure was the home of William W. Lamoureux, a contractor builder. It was constructed circa 1925. The deterioration of the garage was the subject of a complaint first filed in 2011 according to the more recent complaint.

Recommendation: Denial of demolition of the garage as it constitutes **Demolition by Neglect** and that no mitigation of the loss of a significant historic structure has been proved, per the following findings:

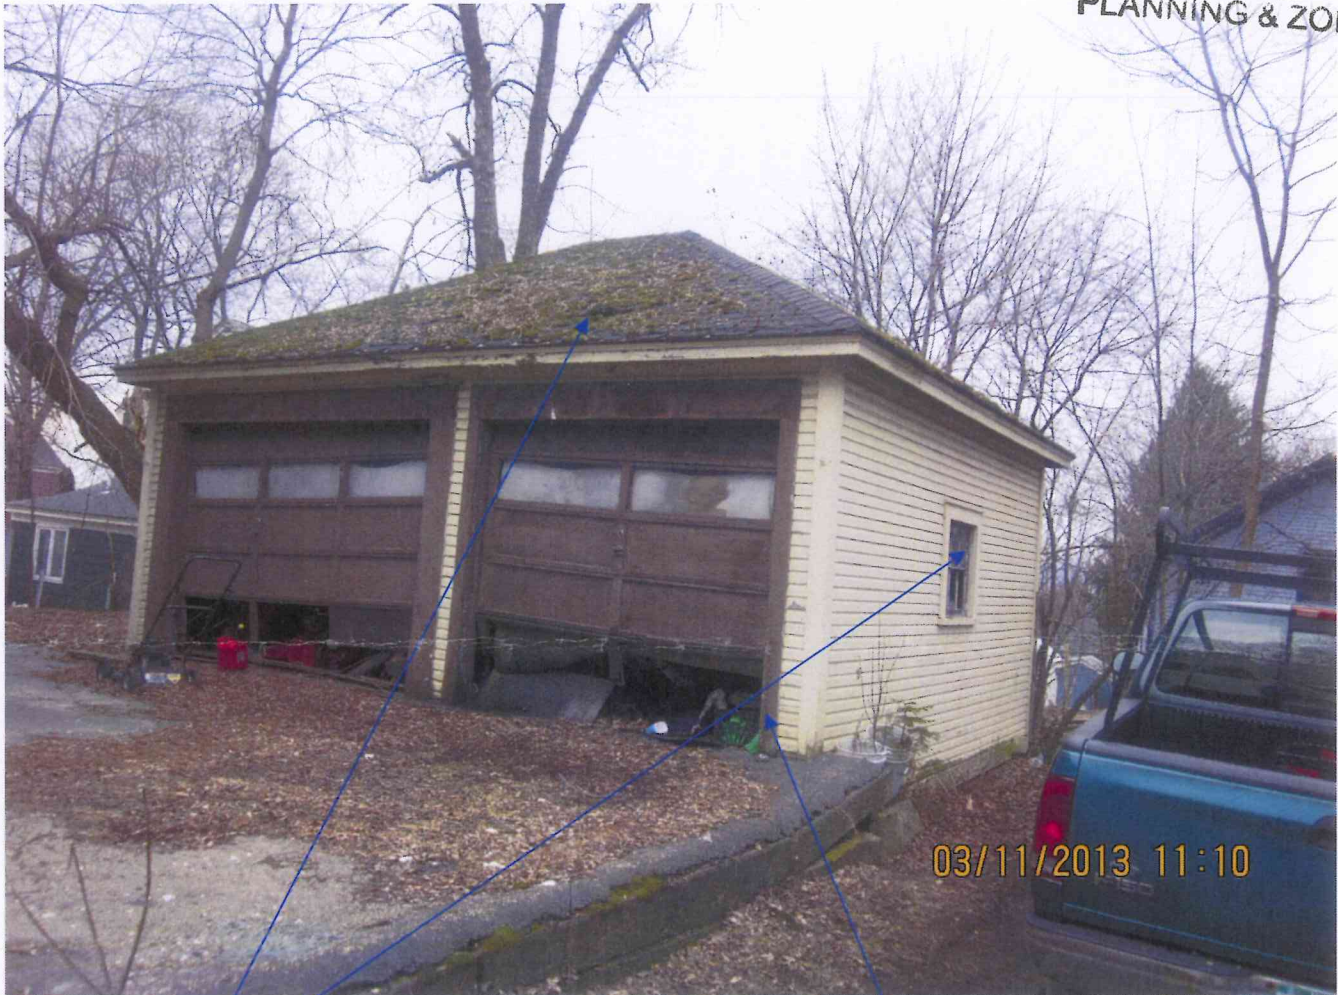
East Elevation: Roof deteriorating (holes, moss, damaged), building's structural dependability is questioned, broken windows.

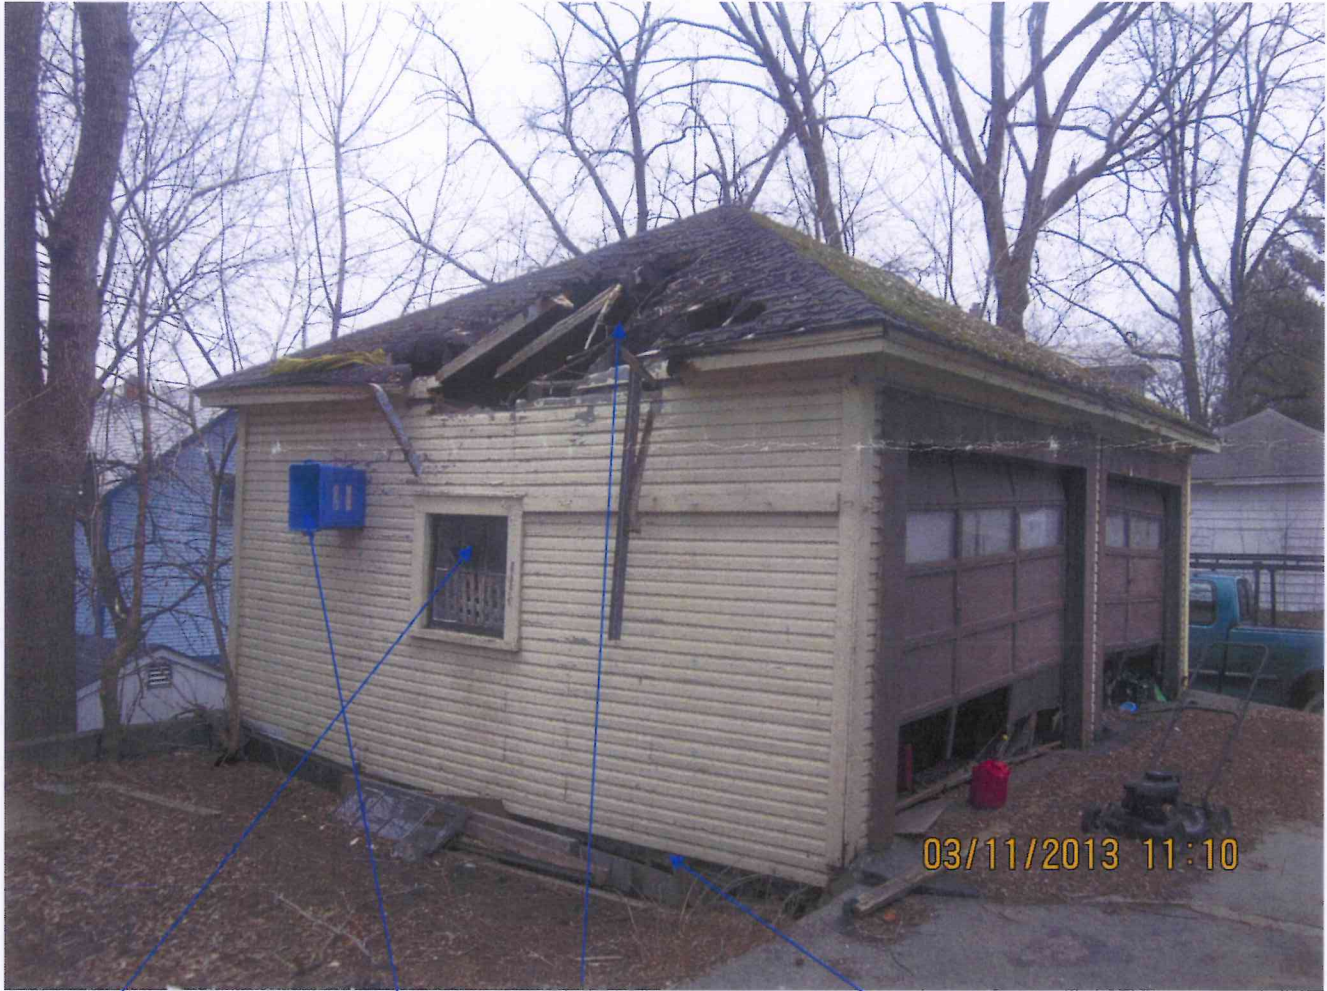
South Elevation: Roof deteriorating (holes, moss, damaged), building's structural dependability is questioned, broken windows. Is this supposed to be an architectural feature?
